## Polychrome from the southern crypt of the church of the Holy Trinity in Byszewo in light of archaeological and conservation studies

Nowak S., Kaźmierczak A. 2019. Polychrome from the southern crypt of the church of the Holy Trinity in Byszewo in light of archaeological and conservation studies. *Analecta Archaeologica Ressoviensia* 14, 169–185

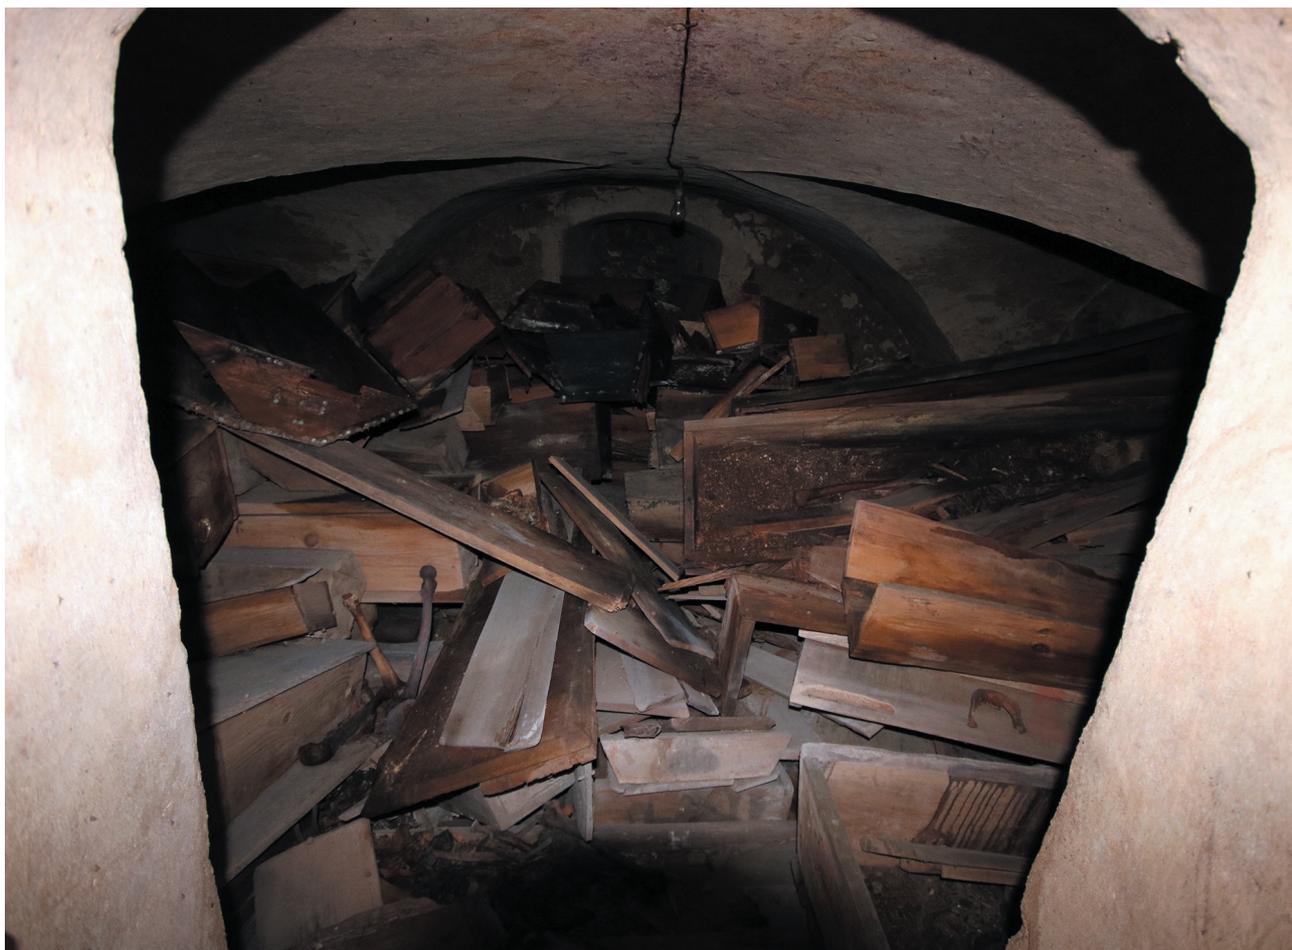
**Fig. 1.** The state of the southern crypt after removing the protective wall which had closed the entrance. Irregular burial layers seen throughout the whole space. Photo by M. Majorek.

The lack of space required a special work method – particular burials were transported to the nave, where they were carefully examined. A series of documentation charts (Fig. 2) for selecting obtained information concerning each burial was prepared (Grupa, Nowak 2019, 6). A burial chart (Fig. 2.1) contained basic

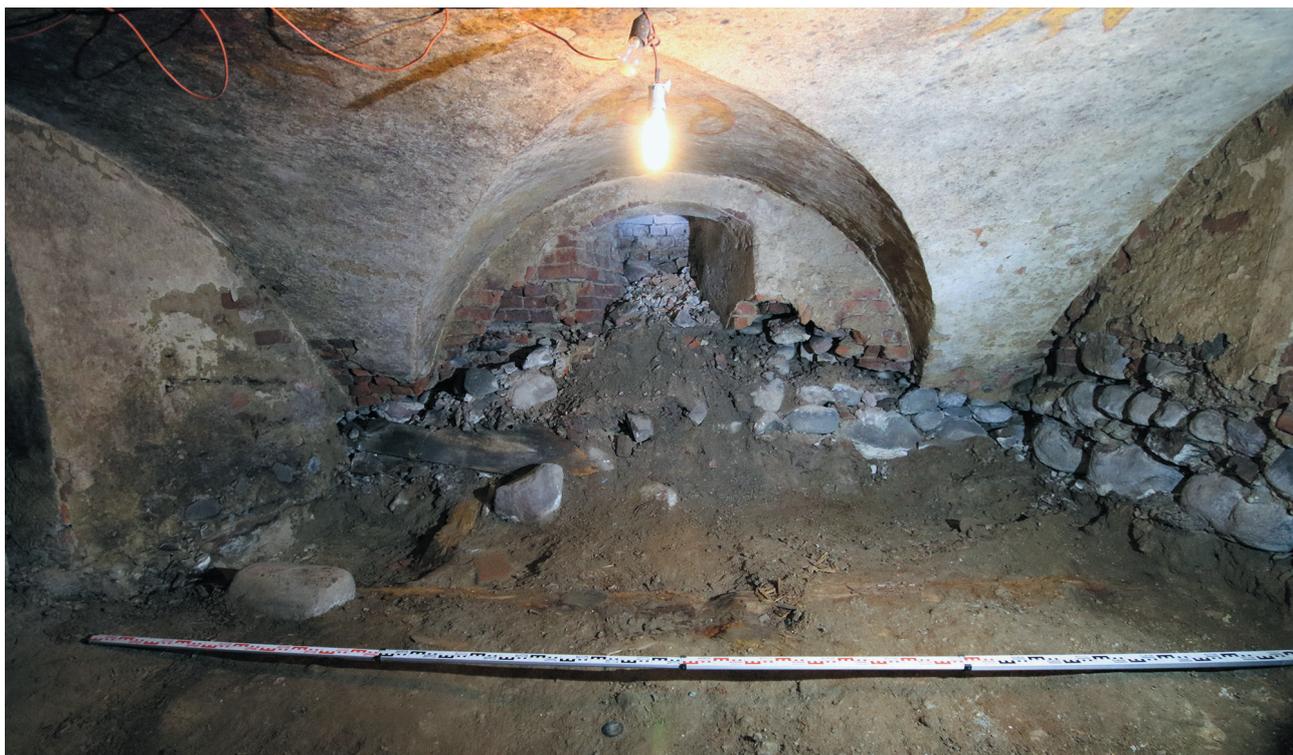
Fig. 3. The crypt's eastern wall: with a ventilation-light opening, the wall's destruction and original wooden joists visible in the crypt pugging. Photo by S. Nowak.

The southern crypt was erected on a rectangular plan with sizes 430 \* 460 cm, with a shift of south-eastern corner. Its walls are compatible with the foundations of the Passion chapel above. Wooden joists (Fig.3) were identified under the burial layers, which originally served to place the coffins on to protect them from direct contact with the pugging of the floor. The floor had places with identified layers of lime mortar, being signs of the plastering of the crypt vaults and walls (Grupa and Nowak 2019, 6, 12).

The eastern (Fig. 3), southern and western walls were equipped with one light ventilation hole each, protected with grates. This probably contributed to the good state of preservation of the grave goods and human remains, which naturally mummified. The situation changed after the bricking up the holes, which caused a lack of air circulation and growing humidity, which finally led to gradual degradation of burials, walls (Fig. 3) and painted decorations in the crypt.

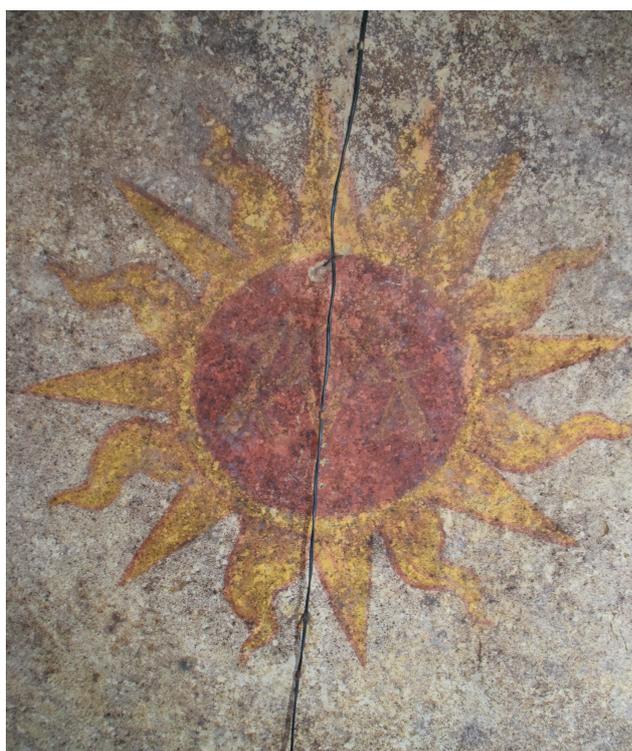
Fig. 5. Solar disc with the cipher *Maria* in solar glory on the barrel vault from the northern side. Photo by A. Kaźmierczak.

The monogram *Maria* (Fig. 5) consists of entangled decorated letters with serifs. The base of the composition is a capital letter “M” with decorative weaving edgings at the sides, and “A” and “I” composed in the middle, with the side arms marked by the letters “R” and “A” directed inside. The Christogram *IHS* is visible practically only in the picture made using UV light and after computer processing. This made a considerable contrast between the background and the drawing (Fig. 6). Letters with serifs were also used in this case. The horizontal line of the “H”, breaks upward in the middle, making a triangle finished with a cross with serifs. Below the line, there are three crossed nails. The UV light photo shows two diagonal lines between the letters “I” and “H” (Fig. 4), which can be interpreted as the author having changed the composition of the letters while painting.

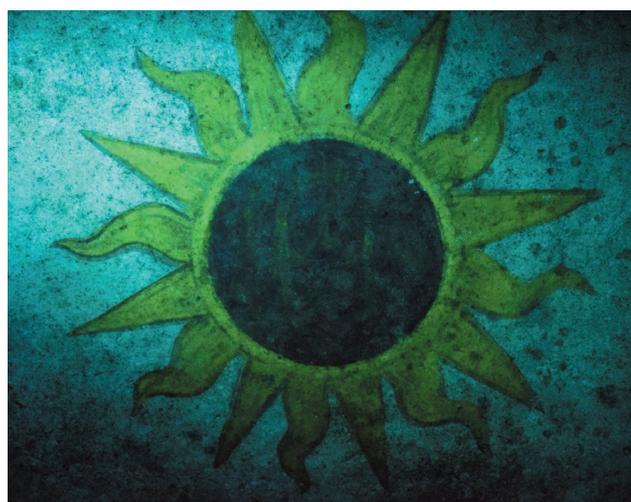
Fig. 6. Solar with the cipher *IHS*, a cross and nails in solar glory on the barrel vault from the southern side using UV light. When the iron red fluorescence is blanked, the monogram outline is better seen. Photo by A. Kaźmierczak.

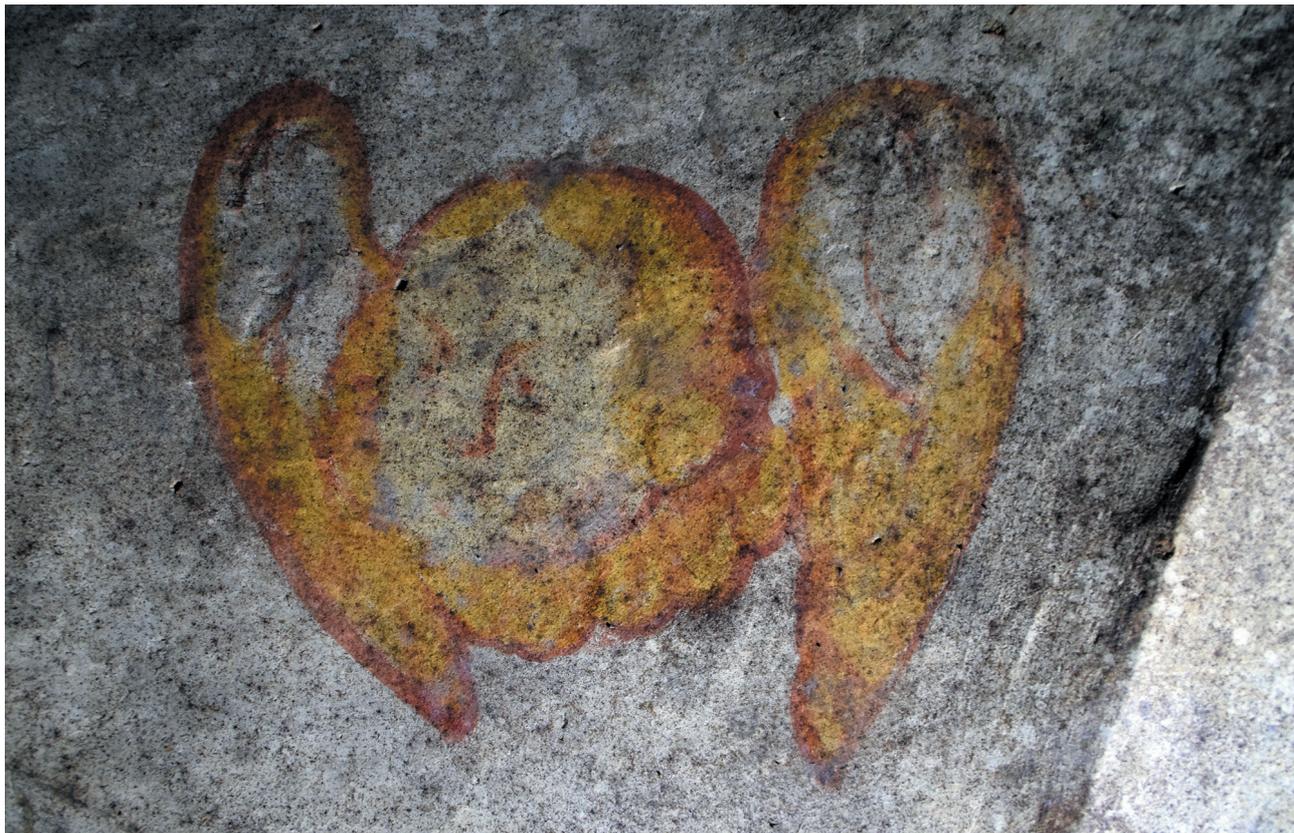
Fig. 7. Putto in the eastern lunette. Photo by A. Kaźmierczak.

The putti are painted similarly, but the western one is preserved in a much poorer condition than the eastern one (Fig. 7–8). The figure composition was made here first of all using a red line. Their yellow faces are round and chubby. Only the large almond eyes and straight noses are schematically marked with red, and the lips were probably made in the same way (the least readable). The putti's yellow hair is short, with red painted weaves and locks. Under their heads there are single fragments of feathers and, at the sides, yellow-or-

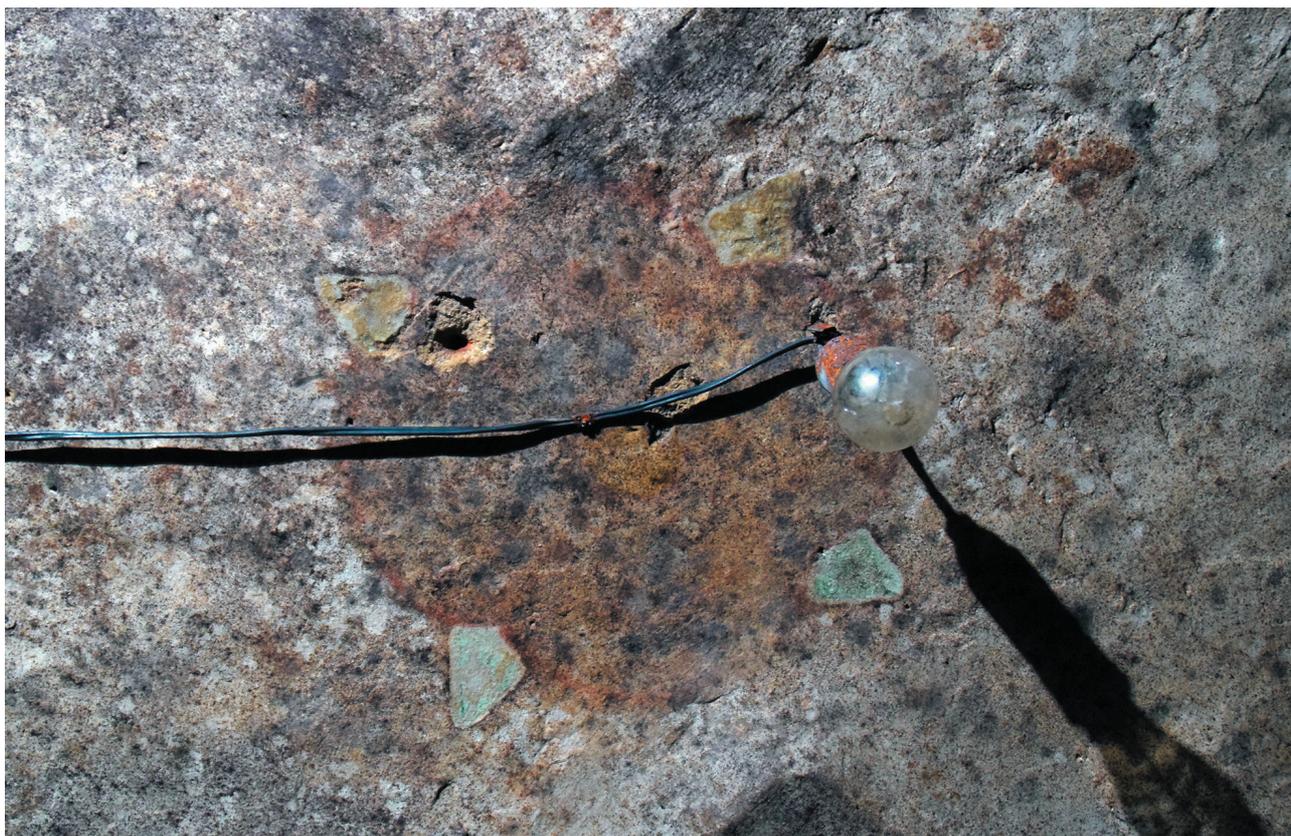
Fig. 9. A flower in the central crypt vault section. Photo by A. Kaźmierczak.

A primitive flower in the middle of a vault (Fig. 9) has four rounded bright orange petals with a small round yellow center lined in red. Straight malachite leaves are small and close triangles. All elements are lined in red.
