Joanna Trąbska, Barbara Trybalska

## **Microstructure of Historical Lime and Lime – Hydraulic Mortars: from Setting to Corrosion**

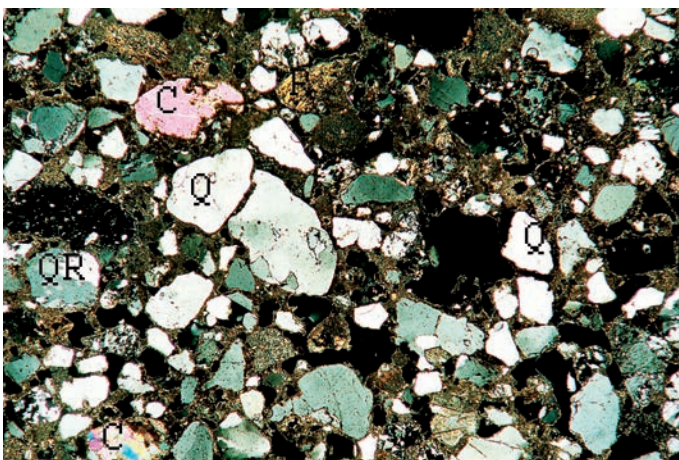
Fig. 1. 14<sup>th</sup> century mortar from the ruins of Czudec Castle. Filler grains are composed of quartz (Q), calcite (C), fragments of quartz rocks (QR), fragments of other rocks (R). Black areas are caverns, pores and cracks. Filler grains are rounded in various degree, they may be grouped in two fractions: around 0.2 mm and around 0.5 mm and coarser. Crossed polars, magn. x 25, Phot. M. Doktor.

Ryc. 1. Zaprawa XIV-wieczna z ruin zamku w Czudcu. W skład ziaren wypełniacza wchodzi kwarc (Q), kalcyt (C), fragmenty skał kwarcowych (QR). Czarne obszary to kawerny, pory i spękania. Ziarna wypełniacza są obtoczone w różnym stopniu; grupują się w dwie frakcje: około 0,2 mm oraz około 0,5 mm i grubsze. Polaryzatory skrzyżowane, pow. 25x. Fot. M. Doktor.

Requirements for a filler quality were rigorous; it is enough to look at Vitruvius' recipes (1999, 54) confirmed by modern researchers and restorers (e.g. Doerner 1975, 172; Mora et al. 1983, 53). They point at application of pure quartz sand; a source of weathered feldspars, mica scales or clay minerals that change their volume in wet conditions is then eliminated. Sea sand was not suggested either: a potential source of easily soluble salts (e.g. gypsum). Contemporary practitioners propose rectangular sand grains or crushed stone, e.g. limestone (*op. cit.*), though Vitruvius does not neglect river sand. Microscopic observations enable to confirm or exclude features mentioned (comp. Fig. 1) above,

Mistakes in mortar production, e.g. adding water during slaked lime and sand mixing, result in appearing of the empty spaces around the filler grains or its parts (Doerner 1975, 72) (Fig. 1).

Features of local workshops can be exhibited due to determination of the phase composition of a filler (e.g. Carpathian sands or tuff material; Fig. 1 and 16), its roundness, size diameter and general degree of care provided to its preparation (e.g. harmful components of the unwashed sand, Fig. 17). Binder reveals also numerous information about: an “echo” of firing processes (Fig. 7, p. 4), slaking and setting conditions (e.g. Figs. 5, 8, 10), process of a mortar production (Figs. 1, 15). All careless actions can be revealed, starting from filler composition through binder features, to structures of filler/binder contact. They were all documented on the photographs. Differences between e.g. mortars from Czudec Castle and Pompei buildings are striking and possible to explain by an analysis of their microstructure.

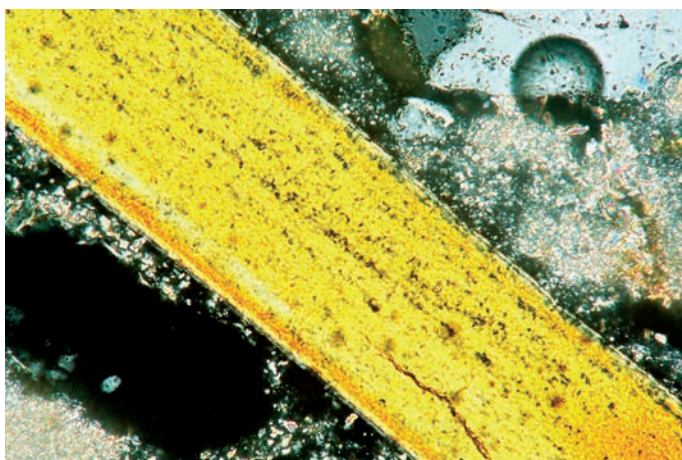
Fig. 12. 14<sup>th</sup> century mortar from Czudec Castle. Fragment of a microorganism, filled with secondary iron compounds. Crossed polars, magn. x 400. Phot. M. Doktor.

Ryc. 12. Zaprawa XIV-wieczna z zamku w Czudcu. Fragment mikroorganizmu wypełnionego wtórnymi związkami żelaza. Polaryzatory skrzyżowane, pow. 400x. Fot. M. Doktor.

Thus, they cannot be regarded as a proof for an 'old age' of mortars. Calcification of organic remnants is a result of percolation of water (either of internal or external, environmental origin) rich in calcium and carbonate ions. Other minerals than calcite may also replace microorganisms, like iron oxides noted in mediaeval mortar (Fig. 12).
